POSTLAUNCH MEMORANDUM REPORT
FOR
MERCURY-ATLAS NO. 7 (MA-7)

PART I - MISSION ANALYSIS

NATIONAL AERONAUTICS AND SPACE ADMINISTRATION

June 15, 1962

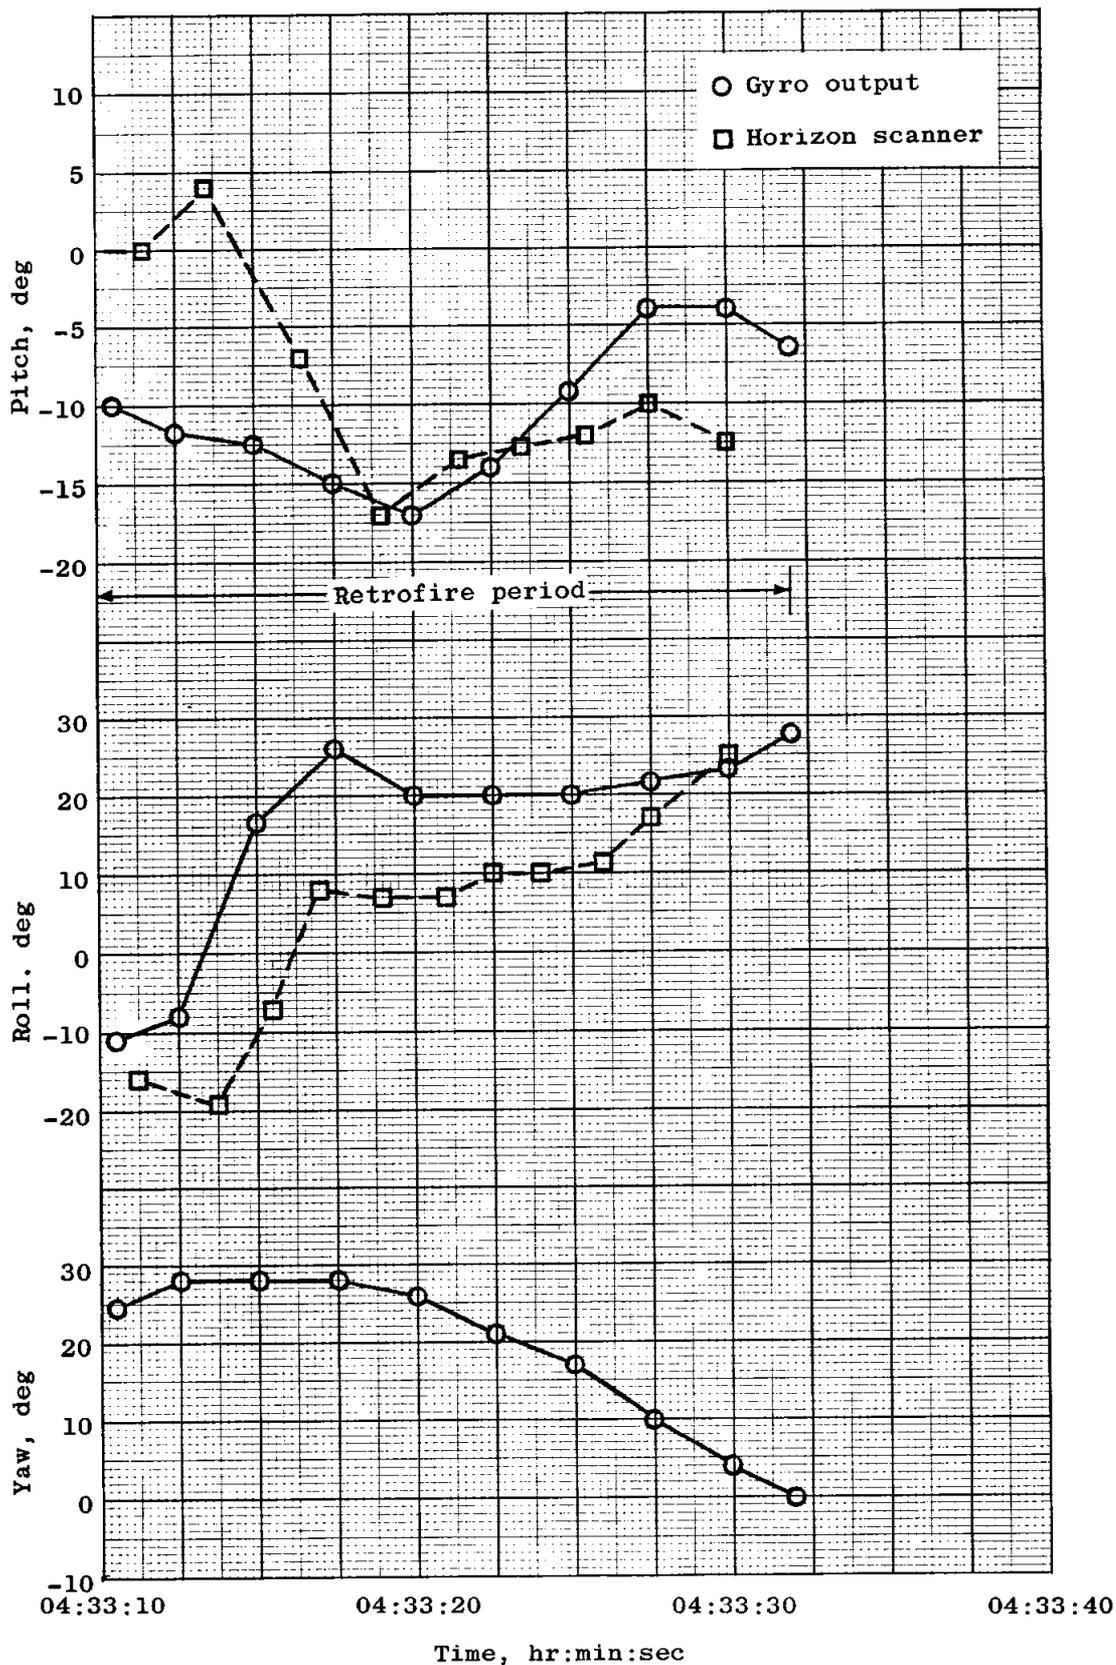
At various times during the orbital phase, the pitch horizon scanner output drifted without apparent spacecraft motion, as was found between 00:07:20 and 00:08:30, where an apparent slaving rate of 20 degrees per minute would be required to duplicate the scanner-gyro reference shift. The nominal gyro slaving rate is 8 degrees per minute. From known astronaut reference positions during the orbital period, the comparable pitch horizon scanner output was observed to be in error by varying amounts between ± 50 and -20 degrees.

Further studies and tests are in progress to localize the nature of the failure. It is believed that the malfunction can be attributed to a random component failure, since the scanner design has previously been qualified.

Figure 7.2.3.6-1.- Horizon scanner and gyro output during retrofire period for MA-7.

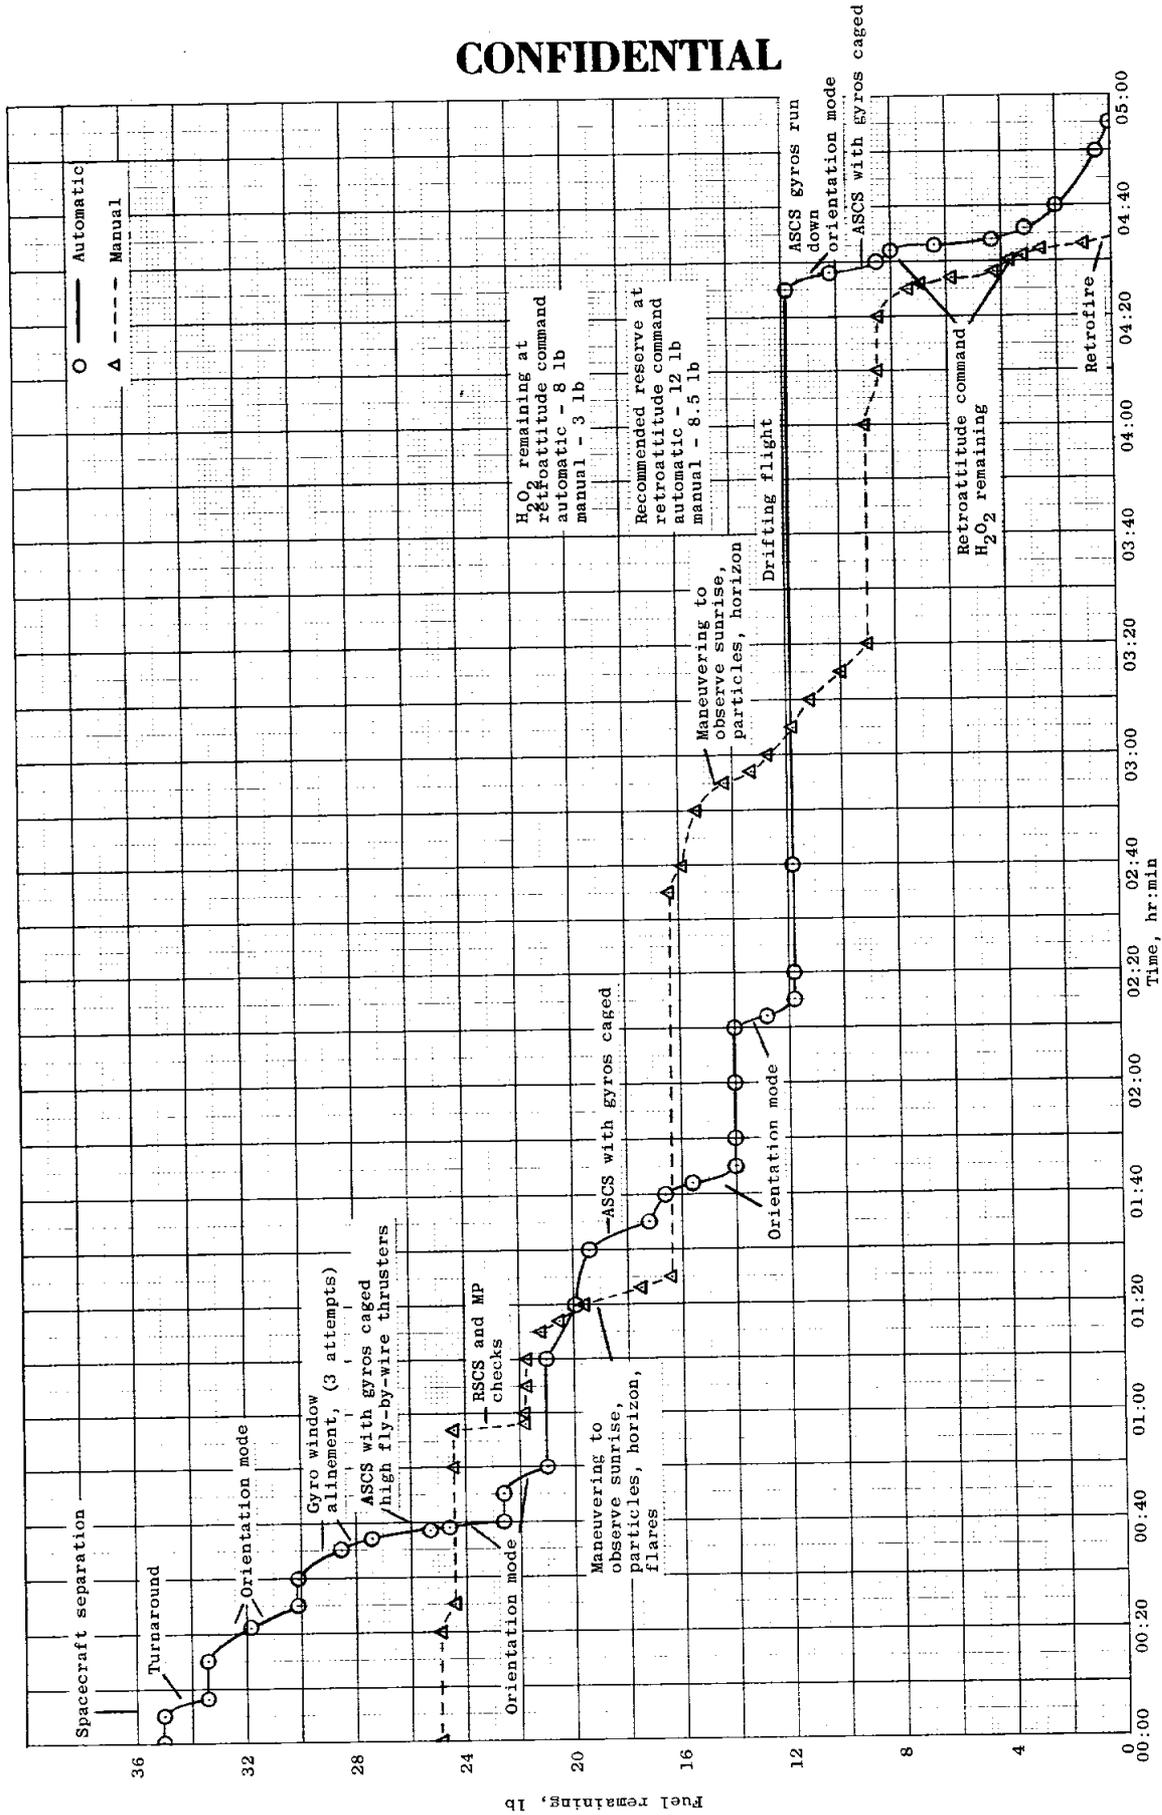
Manual control (FBW and MP) was used extensively during the flight. Approximately 17 minutes of the flight consisted of double authority control. The control system combinations utilized were FBW with MP and ASCS with MP. It should be noted that the high thrusters were actuated inadvertently a number of times by the astronaut while using the FBW control system. It is believed that the repeated use of the high thrusters, together with the use of double authority control, resulted in the unfavorable fuel usage rate, which can be seen in figure 7.2.3.7-1.

Figure 7.2.3.7-1.- H₂O₂ fuel usage.

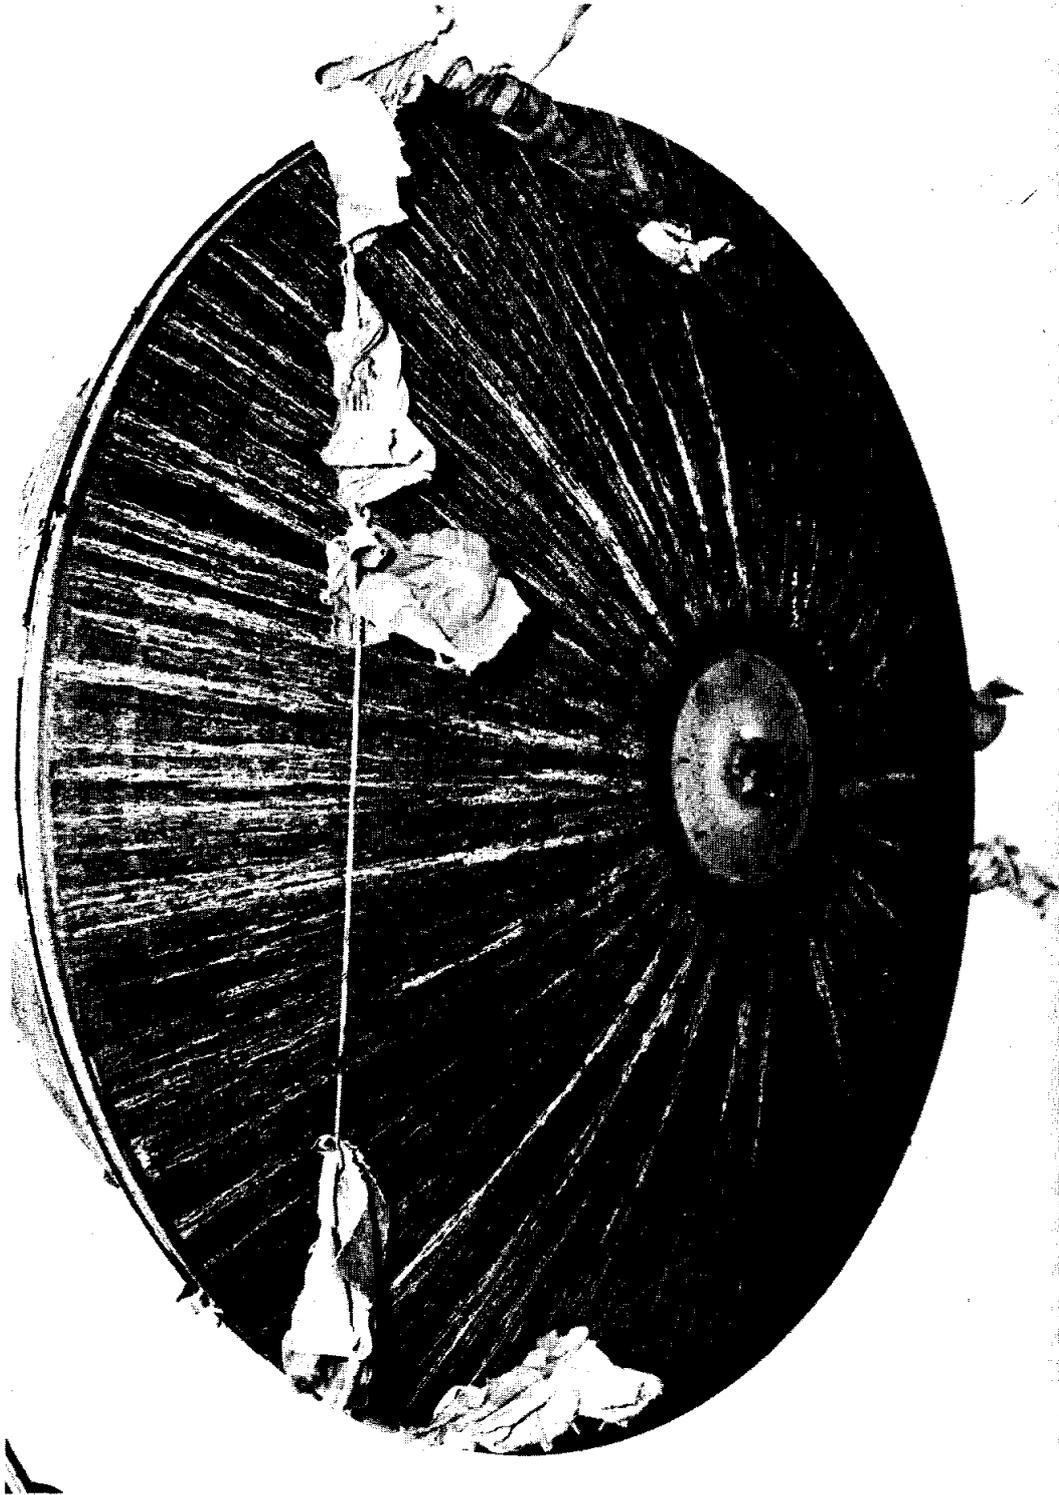
Figure 10.1.2-1.- Postflight photograph of spacecraft 18
ablation shield

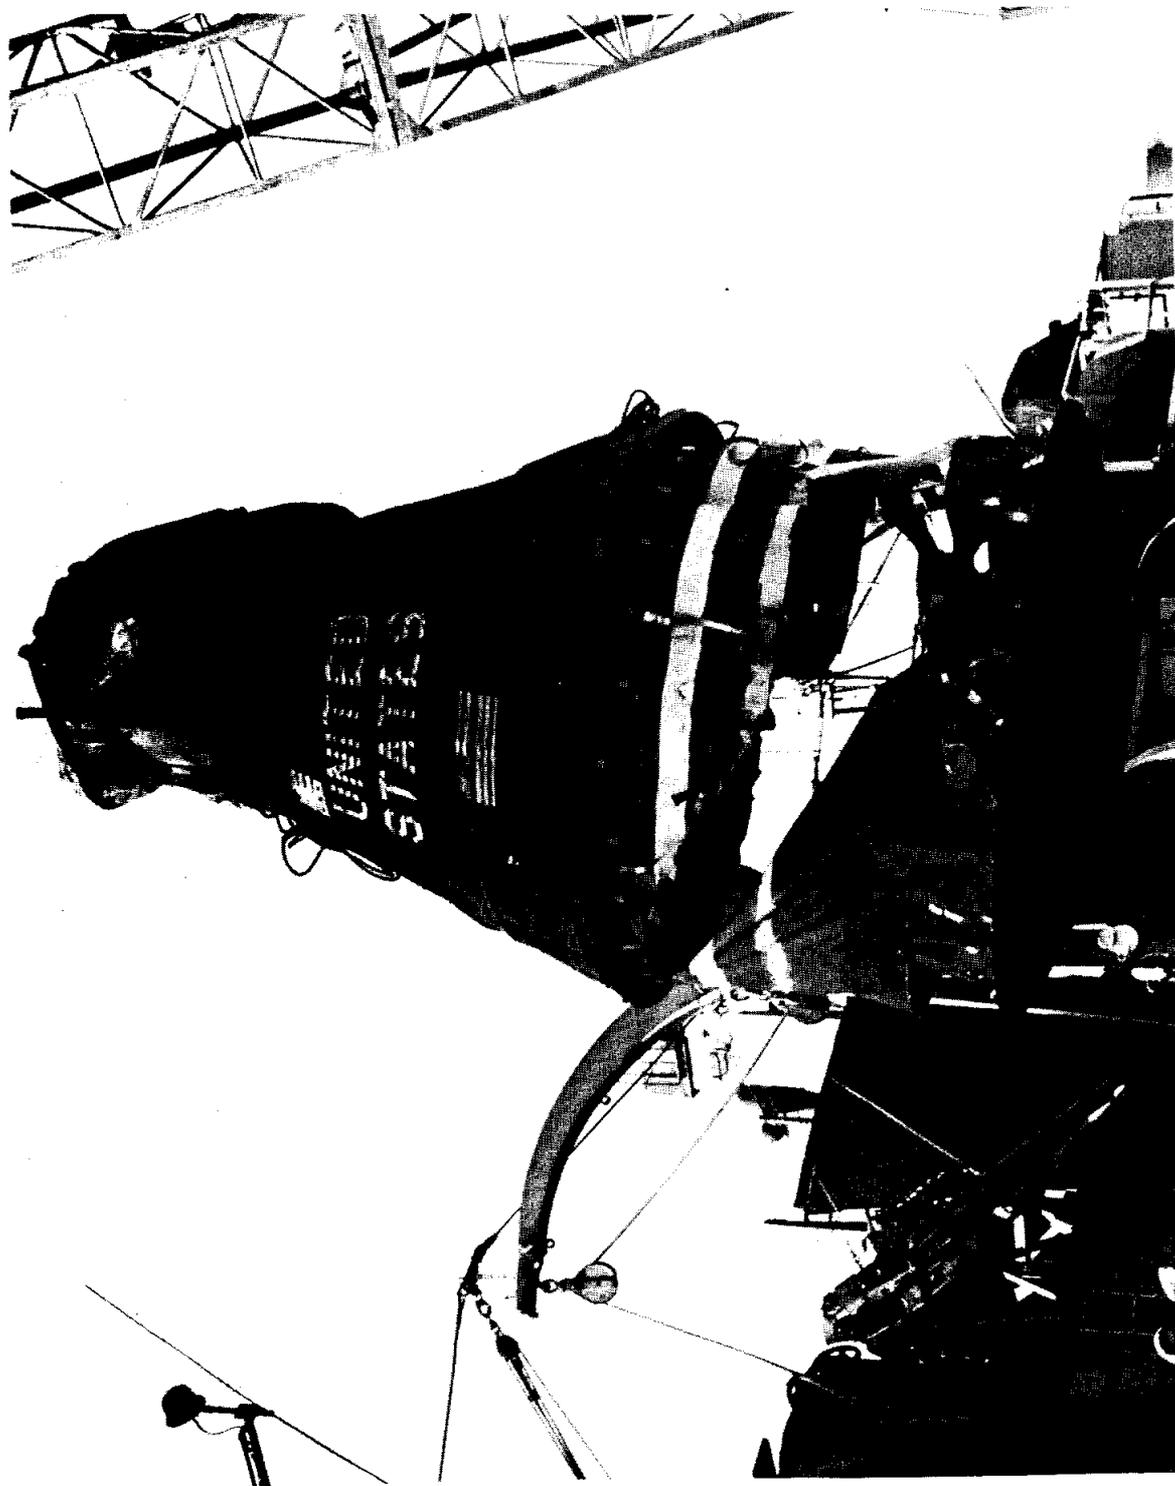
Figure 10.1.3-1.- Spacecraft 18 depicting postflight damage to landing bag and suspension straps.
