AIAA-81-2469
Strength Integrity of
the Space Shuttle

Orbiter Tiles

T.L. Moser and W.C. Schneider,
NASA Johnson Space Center,
Houston, TX

AIAA/SETP/SFTE/SAE/ITEA/IEEE
1st Flight Testing Conference

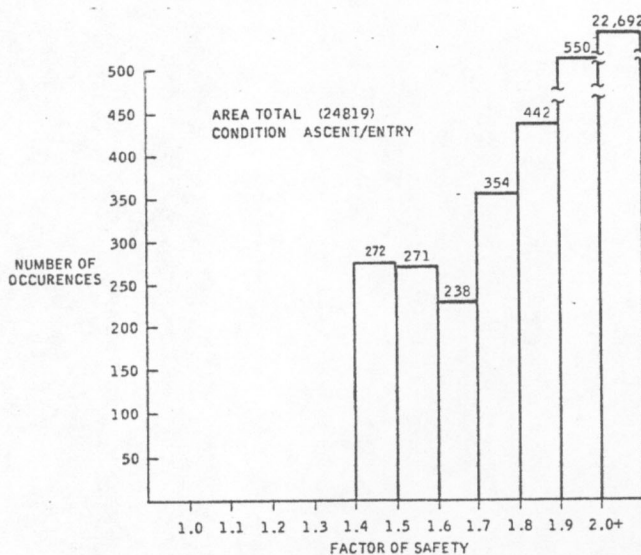
Fig. 9 Factor of safety histogram.

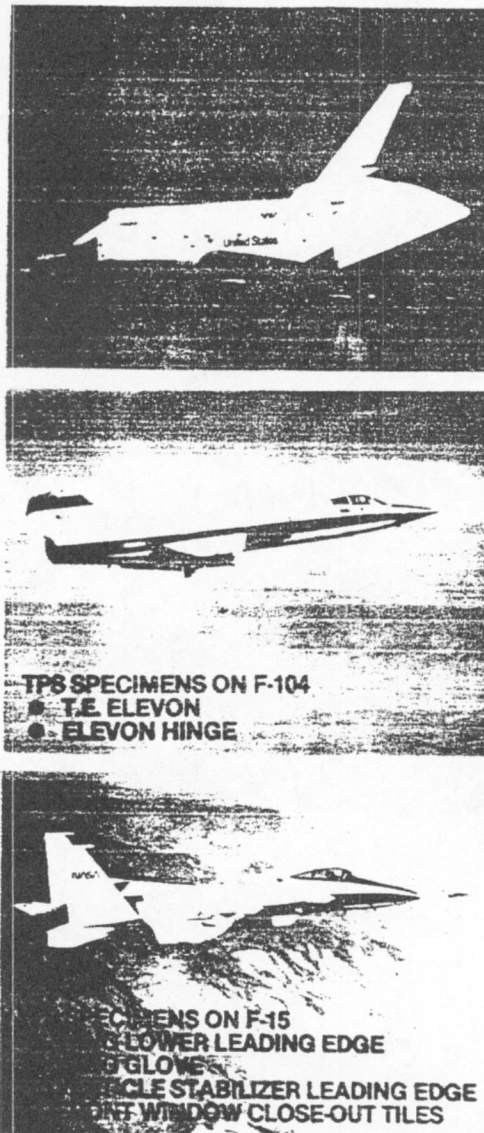
Fig. 11 DFRC in-flight aerodynamic load testing of Shuttle TPS.

A unique approach to aerodynamic tests was used for some of the tile test articles. High-performance aircraft (F-15 and F-104) were used as test facilities (Figs. 11 and 12). Testing full-scale tile arrays to Shuttle ascent conditions in wind tunnels was precluded because of the incapability of available tunnels to achieve the desired conditions. The methods for selecting the test conditions and verifying that same could be attained by the aircraft are discussed in Ref. 2. A summary of some of the aerodynamic test conditions and results is shown in Table 1.
