POSTLAUNCH MEMORANDUM REPORT
FOR
MERCURY-ATLAS NO. 7 (MA-7)

PART I - MISSION ANALYSIS

NATIONAL AERONAUTICS AND SPACE ADMINISTRATION

June 15, 1962

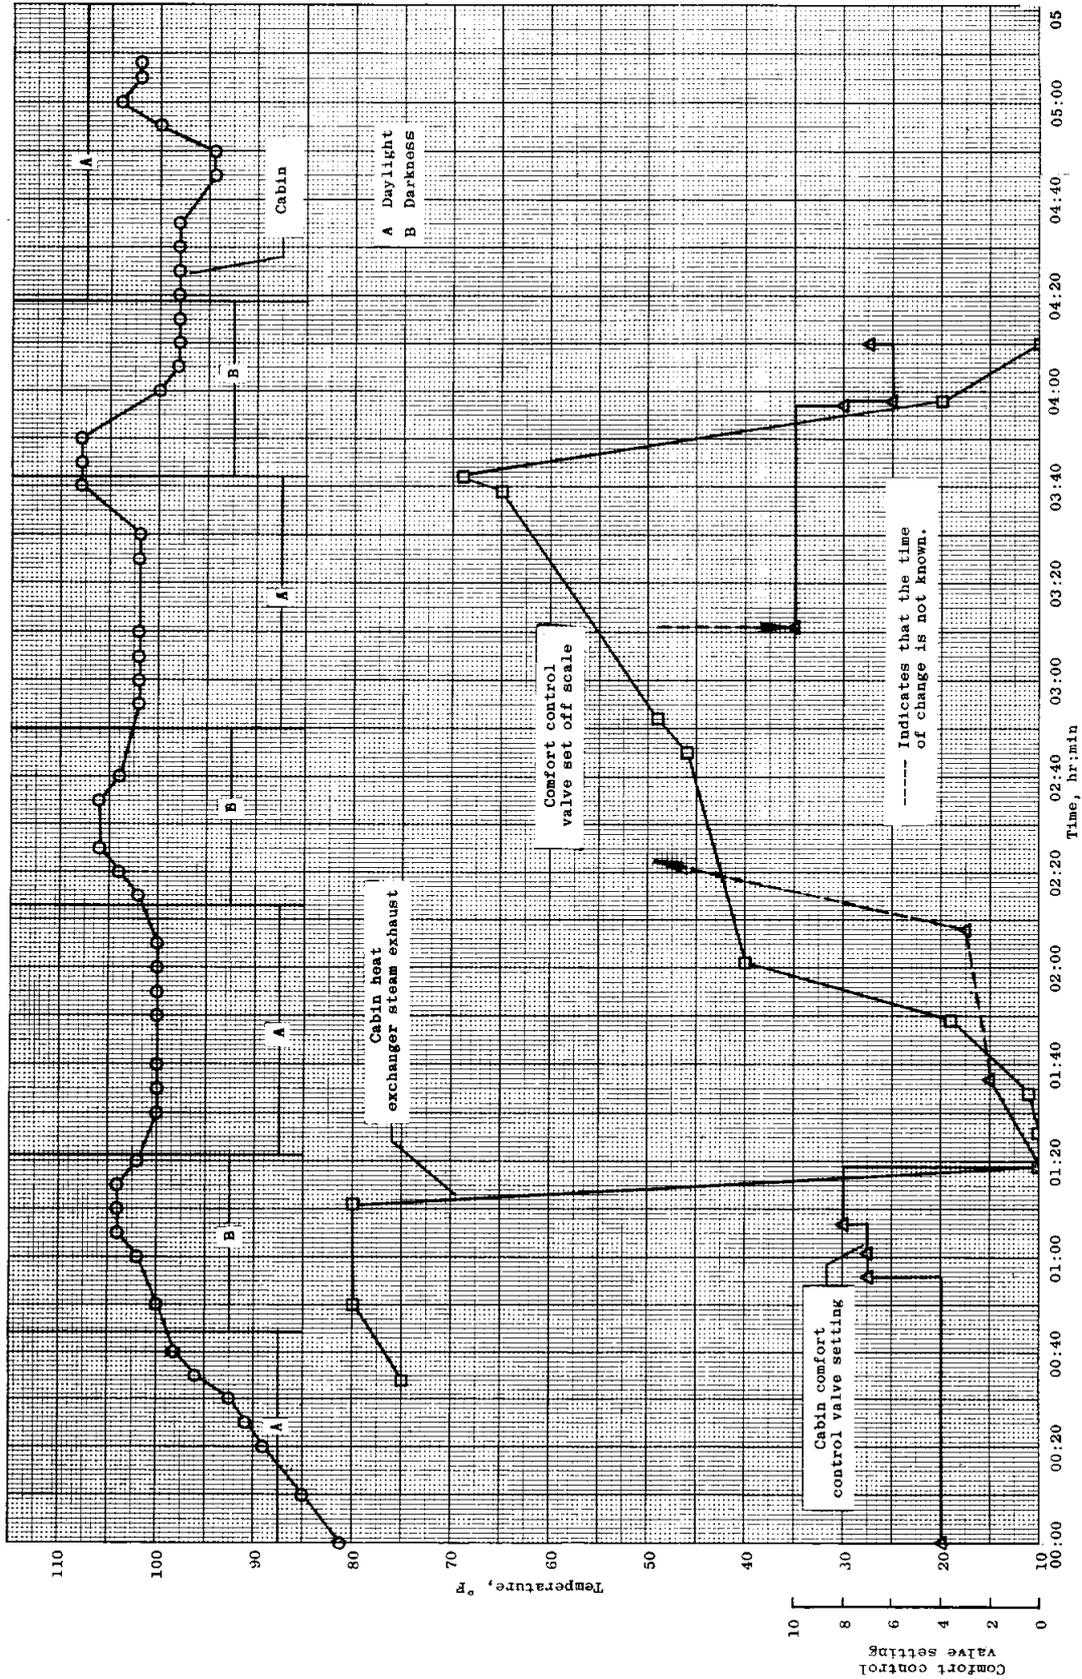
Figure 5.2-1.- Variation of cabin air, cabin heat exchanger steam exhaust temperatures, and associated comfort control valve settings with time.

Although the cabin air temperature varied between 82°F and 108°F, it remained above 100°F for much of the flight. The variation of cabin temperature with time is plotted in figure 5.2-1. These high temperatures, though tolerable, are undesirable. Tests will be made with a larger fan in the heat exchanger to determine if a significant reduction in cabin temperature can be realized.

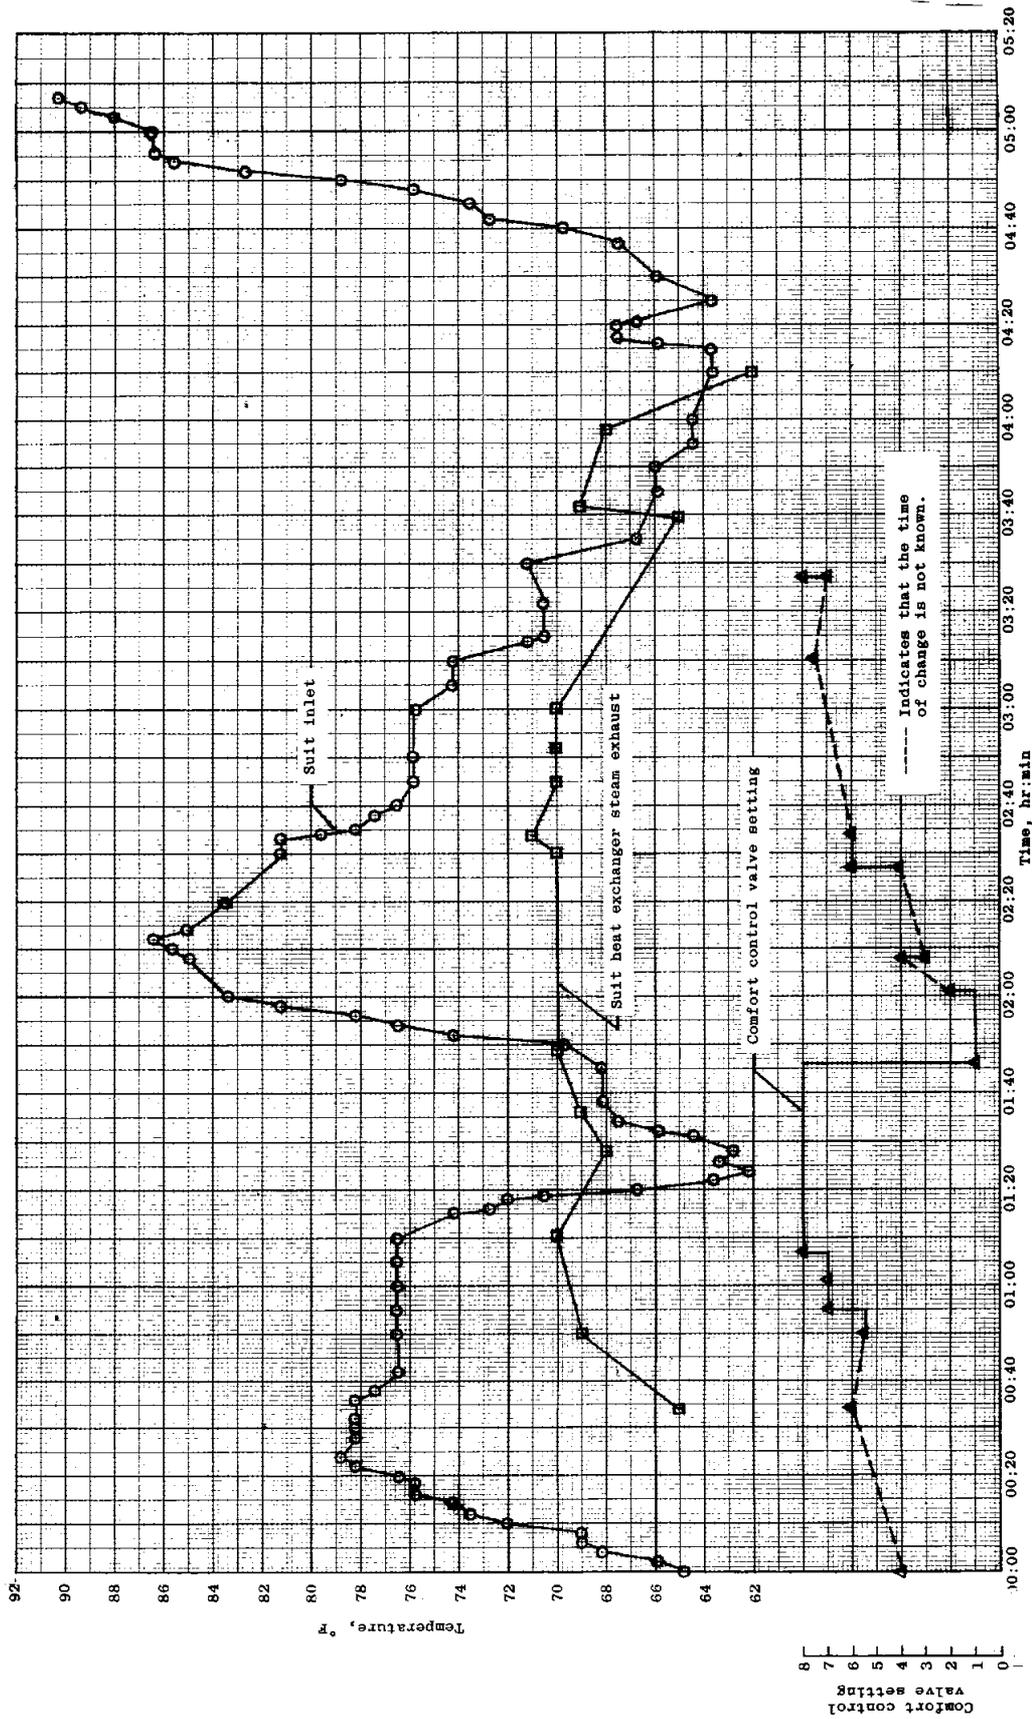
Figure 5.2-2. Variation of suit inlet, suit heat exchanger steam exhaust temperatures and associated comfort control valve settings with time

Suit inlet temperature, suit heat exchanger steam temperature and suit comfort-control-valve settings are presented in figure 5.2-2. The astronaut reported that he found it difficult to determine the proper comfort-control-valve setting which would maintain a comfortable level of suit temperature. Figure 5.2-2 shows appreciable suit-temperature fluctuation resulting from changes in coolant water flow rate (The coolant water flow rate is controlled by the astronaut's manual adjustment of the comfort-control valve).

The suit temperature started to increase sharply at a time of approximately 04:25:00 (figure 5.2-2). About one hour earlier (03:27:00), the suit comfort-control-valve setting had been advanced to give a high coolant water flow rate. The ensuing temperature decrease resulted in a comfortable suit temperature level until about 04:15:00, when a fluctuation began and later the subsequent sharp increase in suit temperature began. It is suspected that freezing of the suit heat exchanger occurred because of a high coolant-water flow rate for this period of an hour. This resulted in a decrease of cooling efficiency just prior to and during the reentry phase.

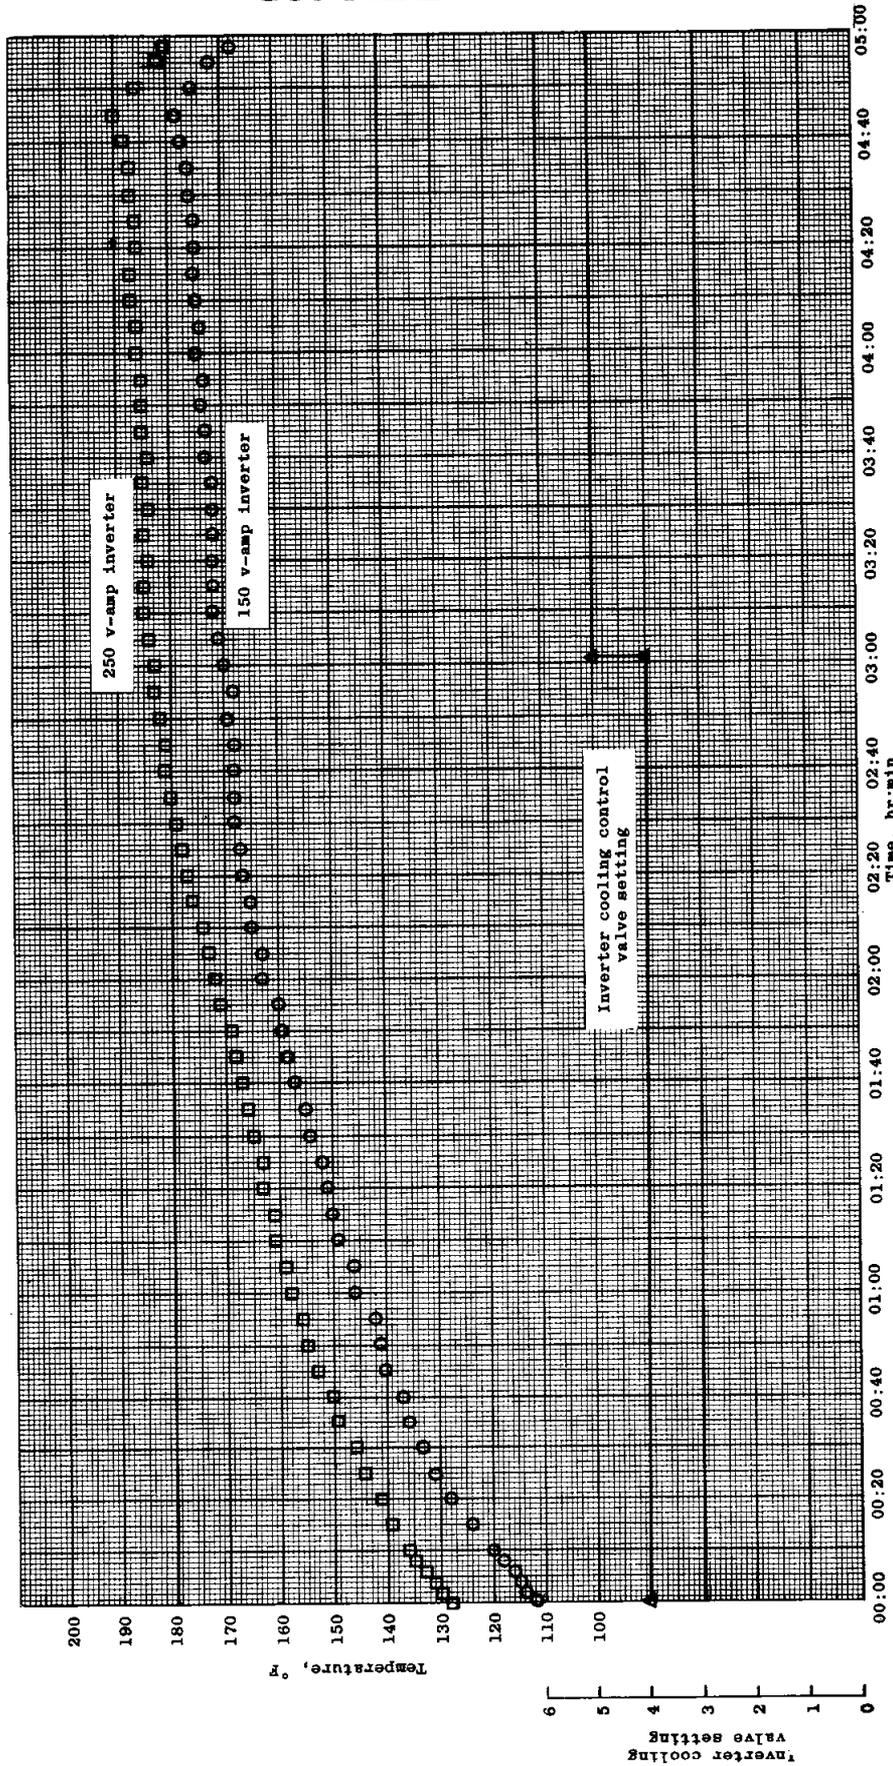
Figure 5.2-3.- Variation of 150 v-amp and 250 v-amp inverter temperatures and associated cooling control valve settings with time.

The 150- and 250-VA inverter temperatures, shown in figure 5.2-3, increased from 112°F and 128°F, respectively, at launch to 175°F and 186°F, respectively, by 04:00:00. The temperatures appeared to be stable after this time. The rate of temperature increase appeared to decrease after the inverter coolant-control valve was advanced from the number 4 to the number 5 position at 03:00:38. The corresponding change in coolant-water flow is from 0.50 pounds/hour to 0.64 pounds/hour.

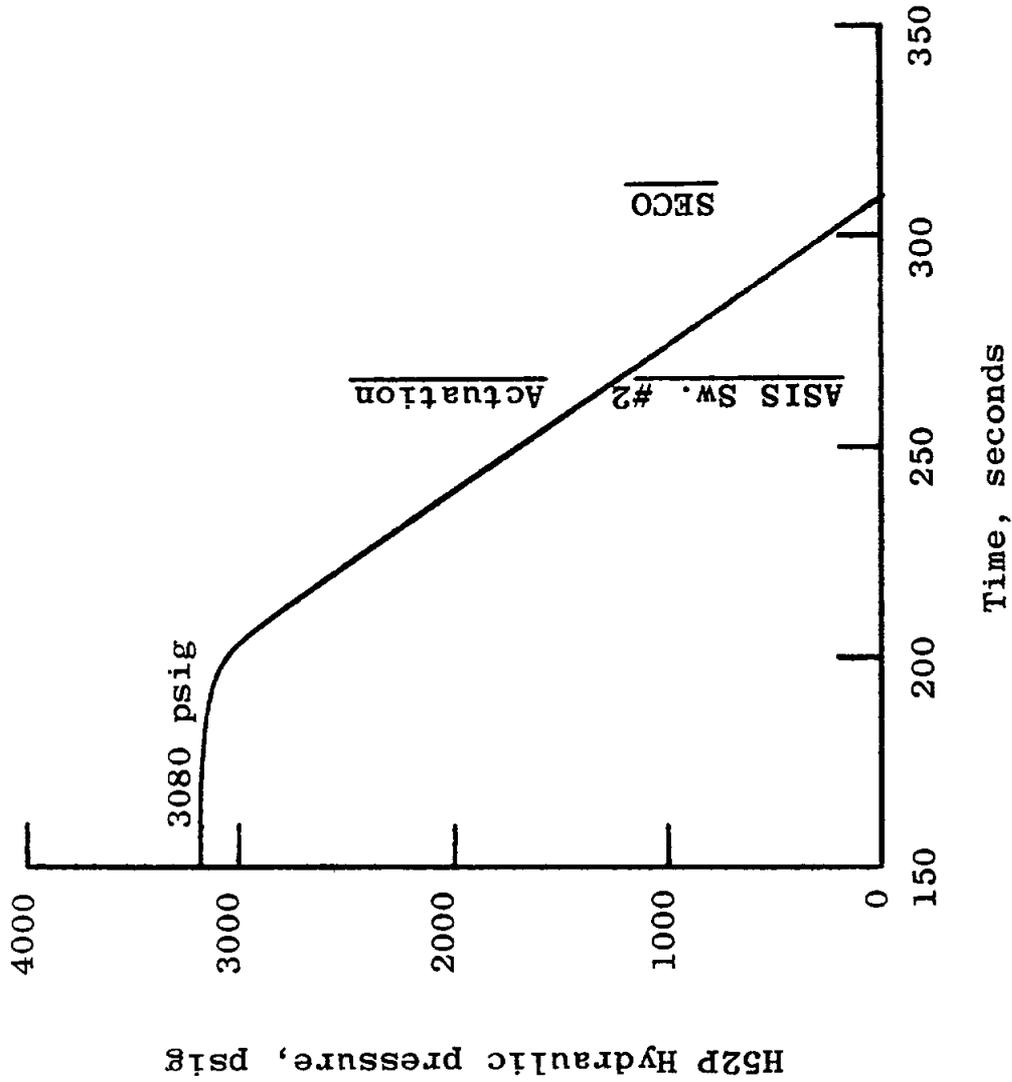
Figure 6.1-2. - Pressure at transducer H52P.

The launch vehicle hydraulic system operated satisfactorily throughout the MA-7 powered flight. The sustainer hydraulic system maintained 3080 psi, as indicated by measurement H 310 P (see figure 6.1-1 for location of this transducer). Hydraulic system pressure measurement H 52 P, which began decreasing at 00:03:10 and reached zero at SECO (see figure 6.1-2) is discussed in paragraph 6.2 below.

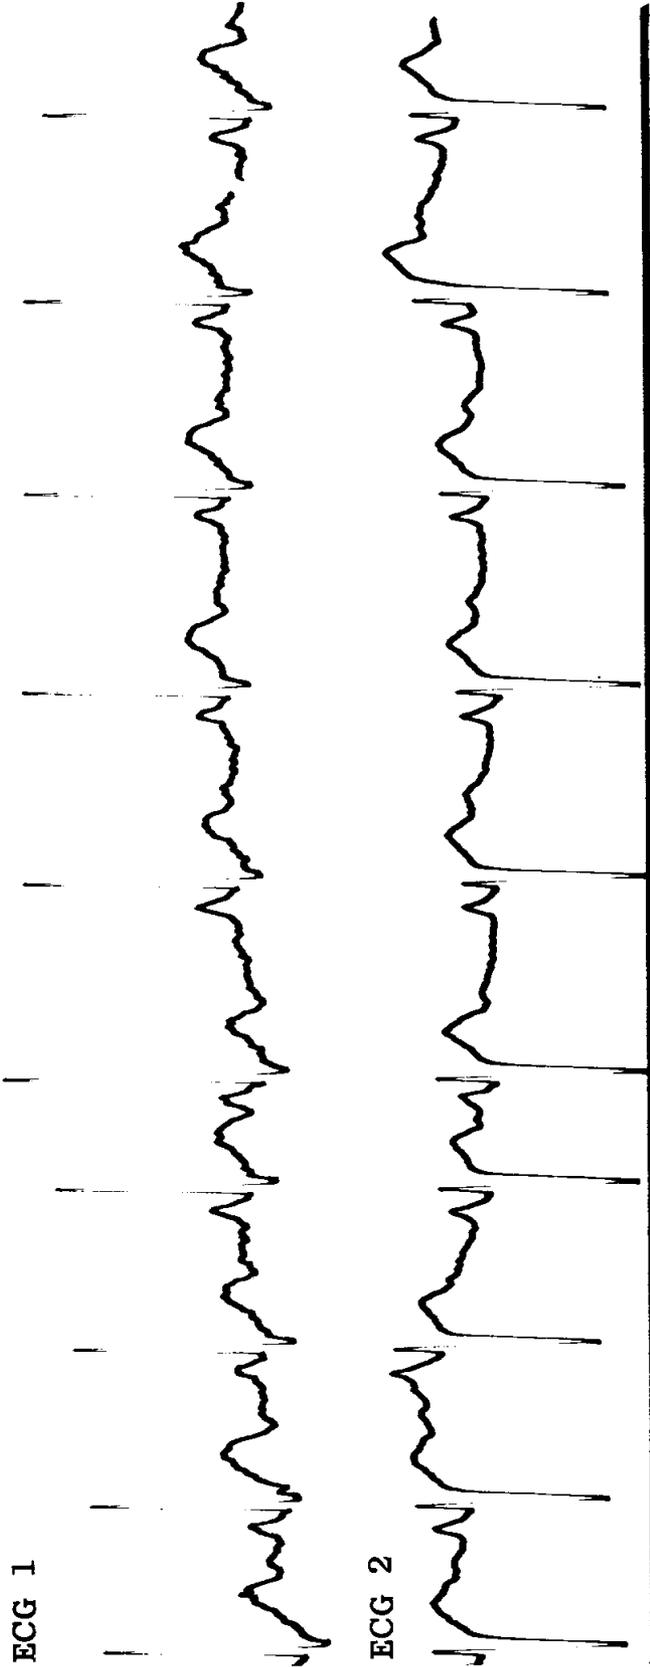
Figure 7.3.2.3-3.- Sample of physiological data from playback of the onboard tape at 04:32:06 mission elapsed time, one minute and 15 seconds before retrofire, illustrating a premature atrial contraction. (Recorder speed 25 mm/second).

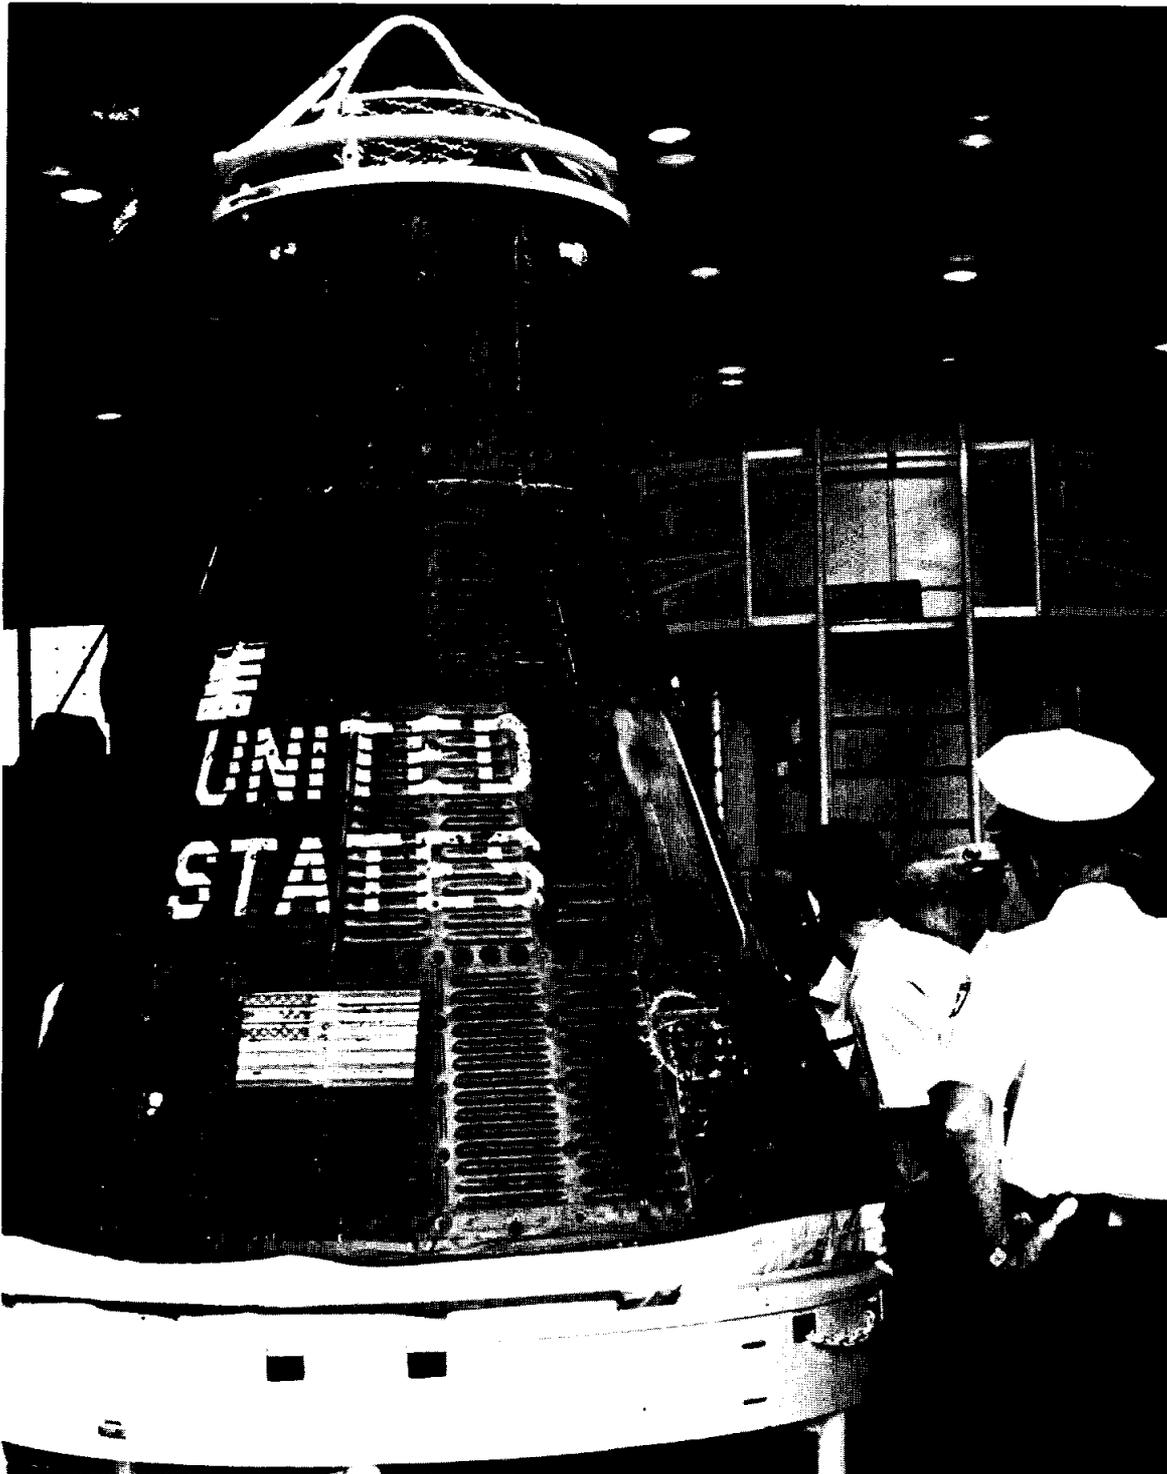
Figure 10.1-1.- Postflight photograph of spacecraft 18 prior to disassembly in hangar S.

Spacecraft number 18 underwent the normal postflight conditioning procedure. A photographic record was made of this process after the spacecraft was returned to Hangar S, Cape Canaveral. A thorough visual inspection was made of the external and internal areas in the "as-received" condition (see figure 10.1-1). Switch and control positions were noted. The spacecraft was then taken to the pyrotechnic area for external disassembly and inspection, and following this, it was transported to the power area for a postflight systems check.
